Manhole Inspection Summary

Manhole # S27S__008MH

Insp Date: **4/25/08 10:49 AM**

Location Address: **1601 Severn ST**

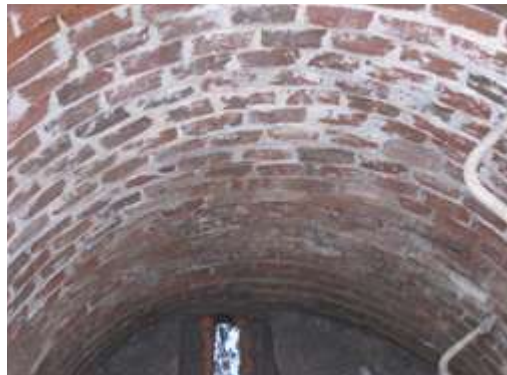
Defect 2

☒ **Evidence Of Surcharge**

signs of surcharge barrel

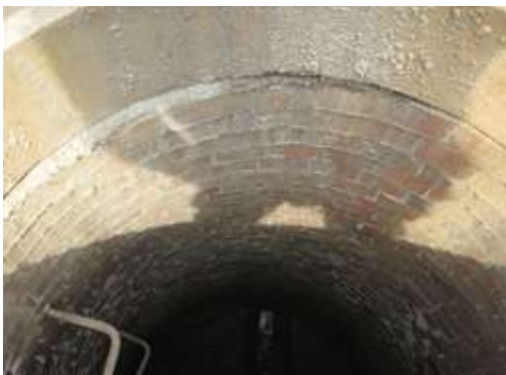
Defect 1

☒ **Leaks**

Infiltration: ☐ None ☐ Joint ☐ Cracks ☐ Mortar ☐ Roots ☒ **Wall**

signs of infiltration frame/chimney to corbel

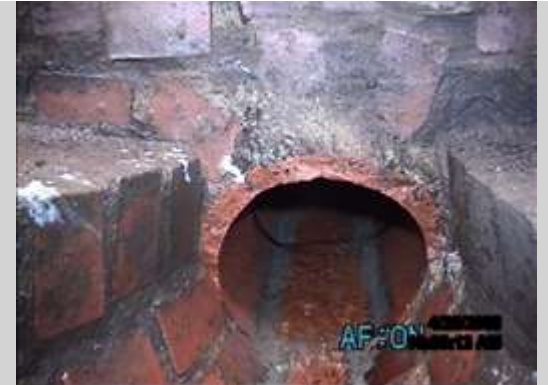
12 O'Clock Outflow

8 in. Circular Gravity Sewer
Pipe Out @ 12 O'Clock

Pipe Height: **8.4** (in.) Rod and Bar (Angled)
Pipe Material: **Clay** ☐ Pipe Lined
Invert Depth: **9.49** (ft.) Flow Characteristics: **Slow**
Deposits: ☒ None ☐ Mud ☐ Sludge ☐ Debris ☐ Grease
Silt Depth: **0** (in.) Deposits Extent:
Infiltration: **None** Pipe Seal Cond: **Sound**

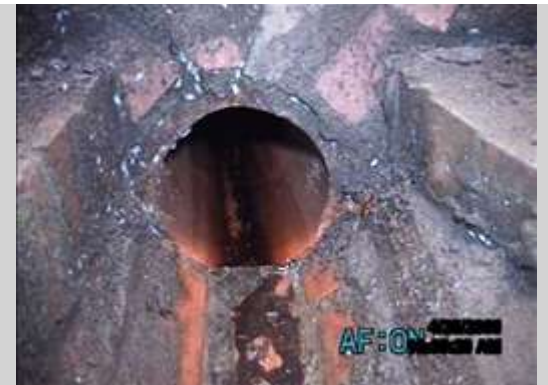
3 O'Clock Inflow

6 in. Circular Gravity Sewer
Pipe In @ 3 O'Clock

Pipe Height: **7.2** (in.) Rod and Bar (Angled)
Pipe Material: **Clay** ☐ Pipe Lined
Invert Depth: **9.01** (ft.) Flow Characteristics: **None**
Deposits: ☒ None ☐ Mud ☐ Sludge ☐ Debris ☐ Grease
Silt Depth: **0** (in.) Deposits Extent:
Infiltration: **None** Pipe Seal Cond: **Sound**

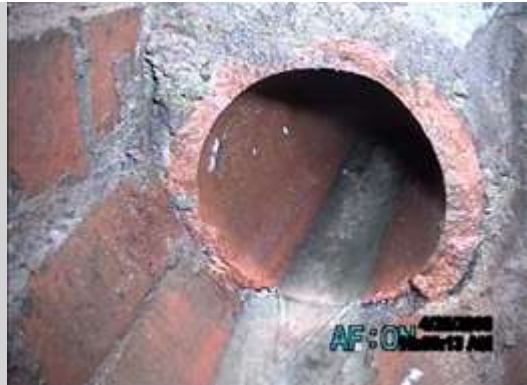
9 O'Clock Inflow

6 in. Circular Gravity Sewer

Pipe In @ 9 O'Clock

Pipe Height: **7.2** (in.) Rod and Bar (Angled)

Infiltration: **None**

Pipe Seal Cond: **Sound**
